The Electronic Anti-Scale System

Cooling Tower Information

CWT
Christiani
Wassertechnik

EN - 08/2014

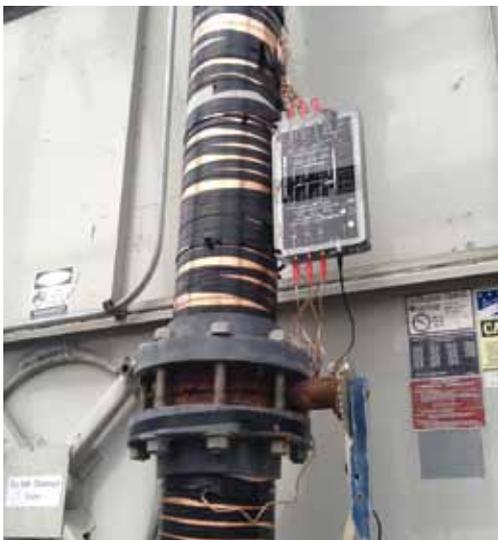
Please find below the installation photos of the Vulcan S100 installed on the main line connected to 3 cooling towers.

Vulcan S100 installed on cooling towers

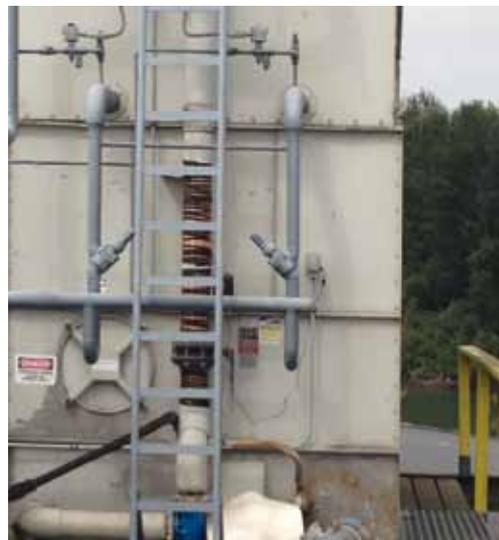
Vulcan S100 installed outside

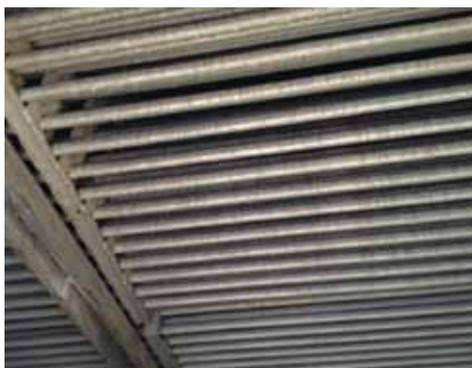
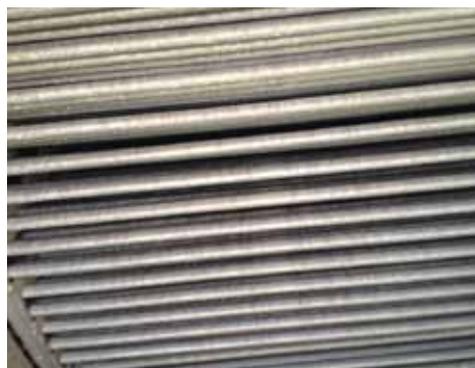
This picture was taken after 4 months the installation of the Vulcan S25. The tower was dirty/not cleaned before the Vulcan was installed.

Since the Vulcan installation, the cooling towers have been scale free and there has been no need for any chemical treatment.

Clean cooling tower after using Vulcan

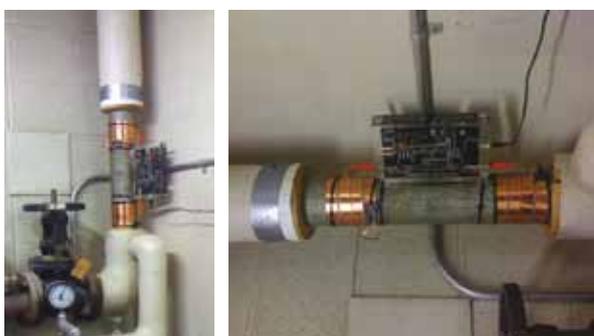
Installation of Vulcan Descaler for the entire buildings water supply in the Roosevelt school

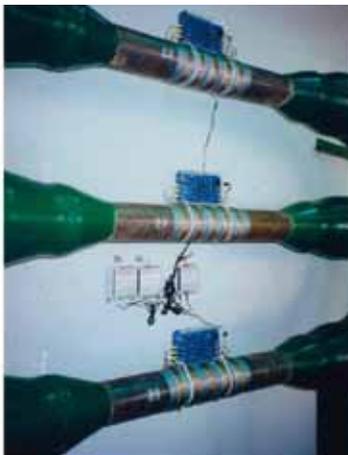
After Vulcan installation

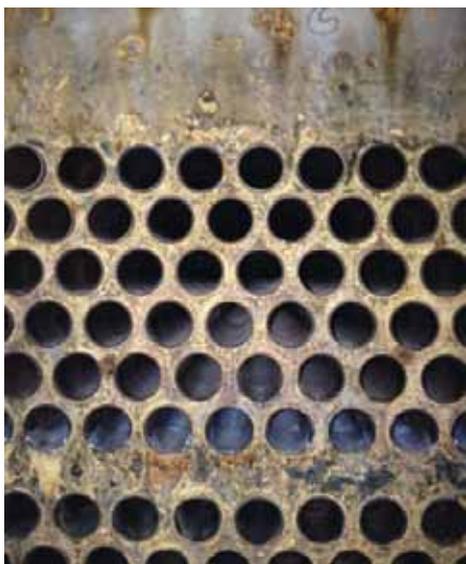
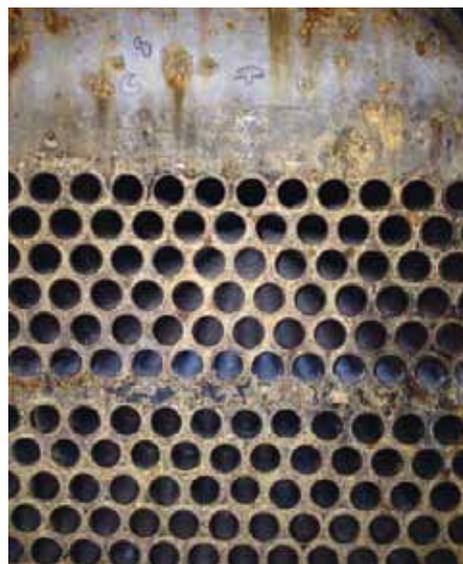
Here are two pictures from a Chiller opened for a routine cleaning, but nothing to clean after two years with Vulcan treatment.

No scale formation after using Vulcan

This Chiller is connected to a Cooling Tower which is exposed to lots of air borne contamination from surrounding farms.

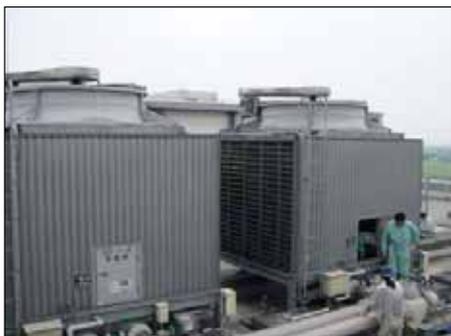
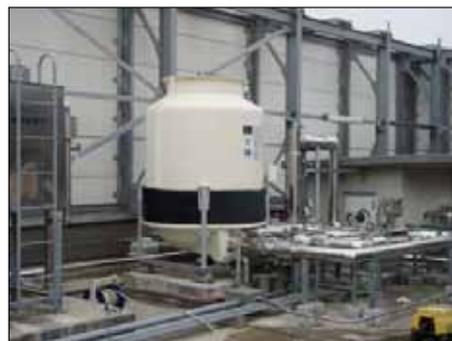
Developments after installation of the Vulcan

Adhesion of silica six month after the installation of the Vulcan

Silica is not removed by hosing, but can be peeled off with a nail.

Silica is removed by simply hosing the water. (The remaining silica is peeled off with a touch of a finger.)

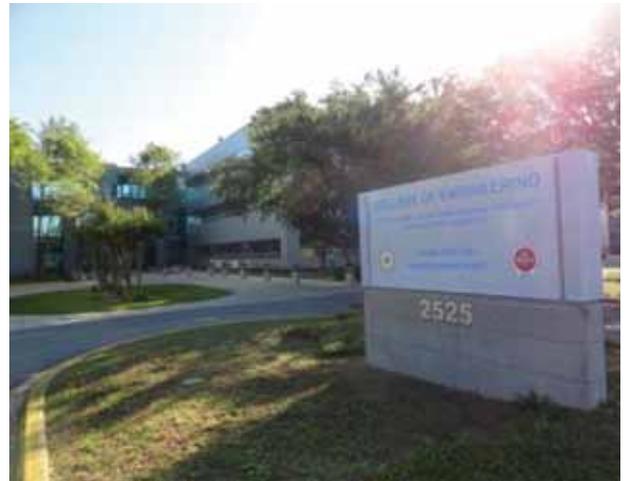
The unit was installed on the 10 inch diameter line that feeds twin cooling towers (CT-1 and CT-2) at the FAMU/FSU College of Engineering.

Vulcan S250

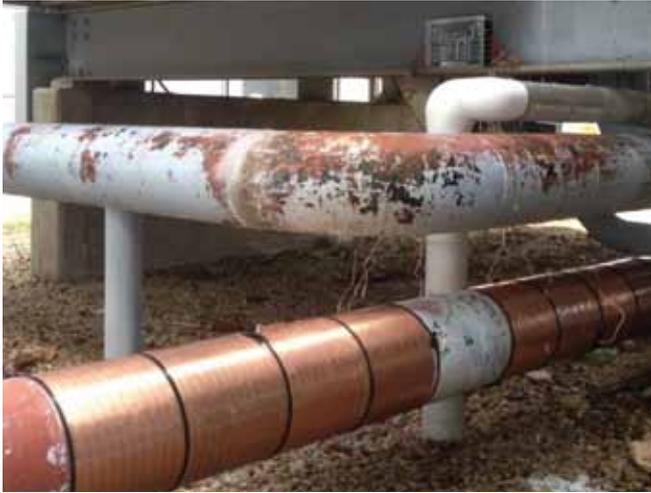
Vulcan S250 installed on a 10 inch diameter line that feeds twin cooling towers (CT-1 and CT-2)

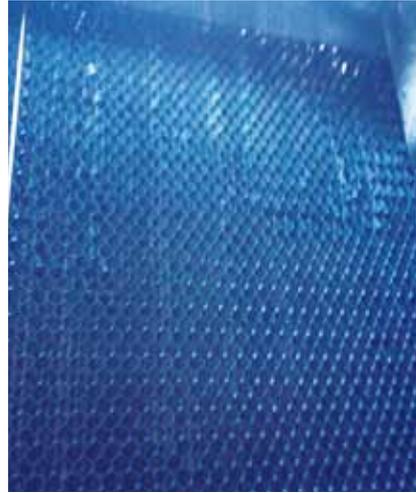
This photo was taken of the inside of CT-1 on August 9, 2013.

It illustrates clean flutes that are in constant contact with Vulcan-treated water and a few dry (untreated) areas that still have some remaining green biofilm.

Between the time of the installation on July 16th and examination on August 1st, the green biofilm had begun to recede and gradually disappear. The next visit was about 3 weeks after the installation, on August 9th. At that point, the green biofilm had been further reduced and the scale deposits had begun to separate from the flutes in coin-sized flakes.

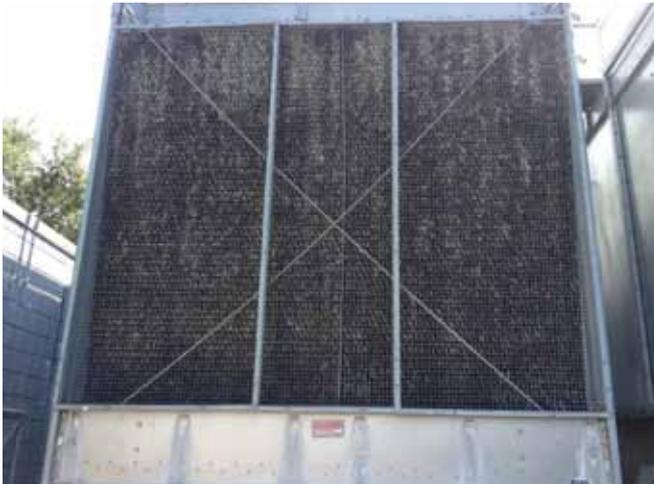
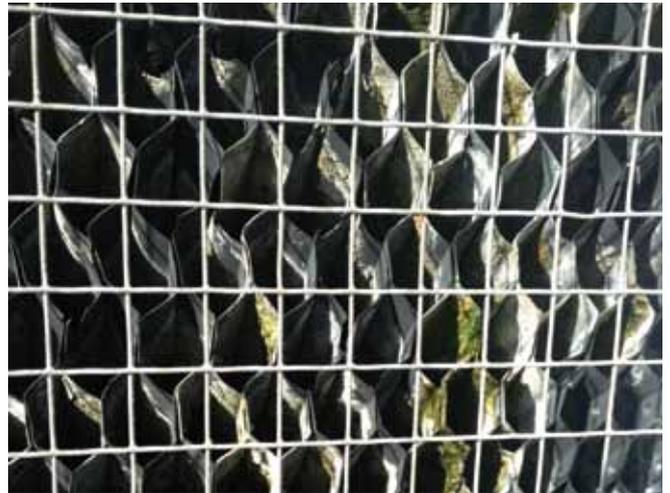
The photographs above were taken of CT-1 about 3 weeks after the Vulcan was installed (August 6, 2013).

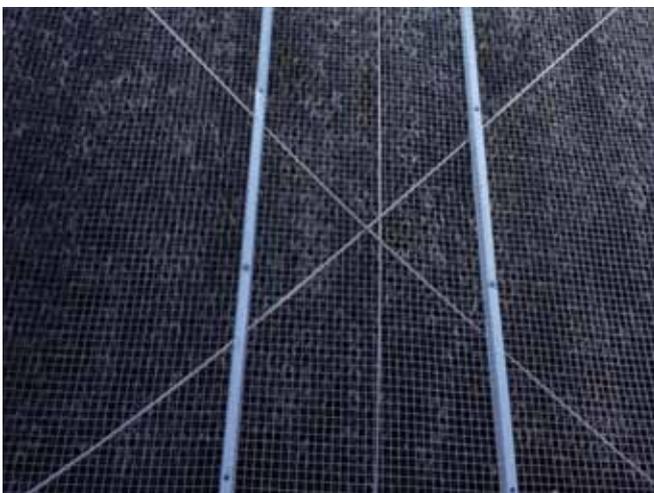
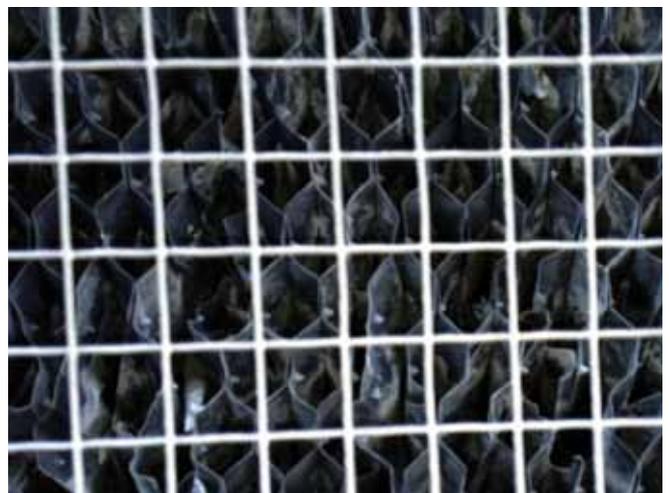
These photos were taken of CT-1 after about 6 weeks (August 20, 2013).

By August 20th, about a month after installation, the green biofilm had almost completely disappeared from the surfaces in contact with the Vulcan-treated water. The flakes of scale previously observed had fallen off in most places. The cooling tower flute surface area covered with scale deposits had been decreased by over 60%.

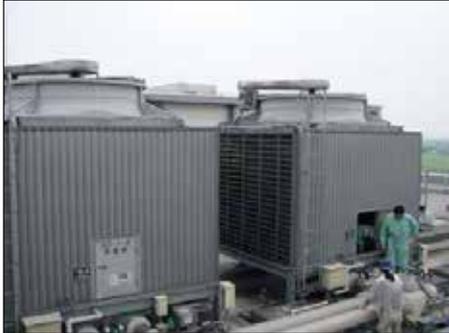
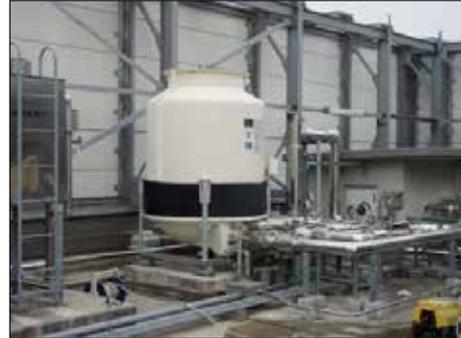
Cooling Tower A Cooling Tower B

Developments after installation of the Vulcan

Adhesion of silica six month after the installation of the Vulcan

Silica is not removed by hosing, but can be peeled off with a nail.

Silica is removed by simply hosing the water. (The remaining silica is peeled off with a touch of a finger.)
